Stanley W. Trimble
Geog. Dept., U. of Ga.Field Investigation Reports to Accompany
the M. A. Thesis, Culturally Accelerated
Sedimentation on the Middle Georgia Piedmont (U. of Ga, 1969)

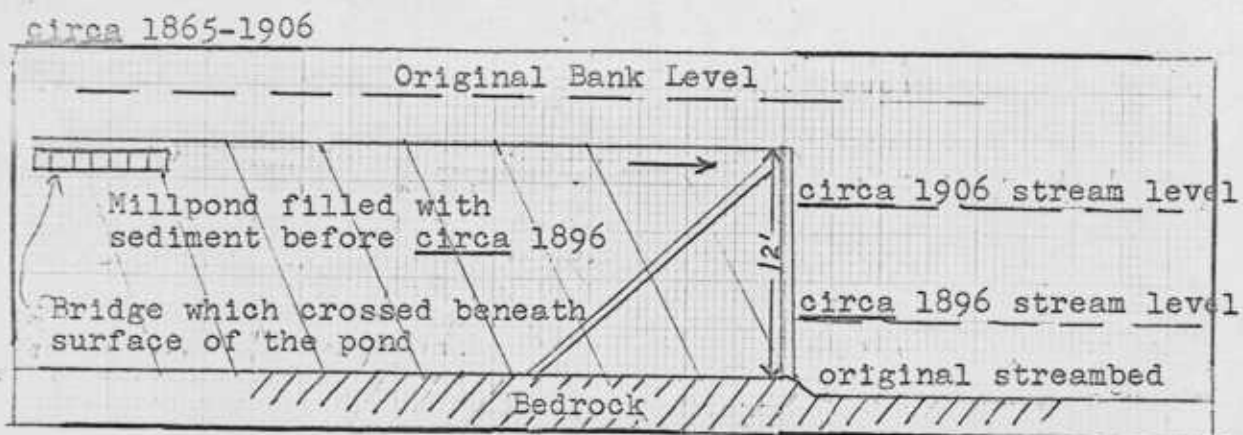
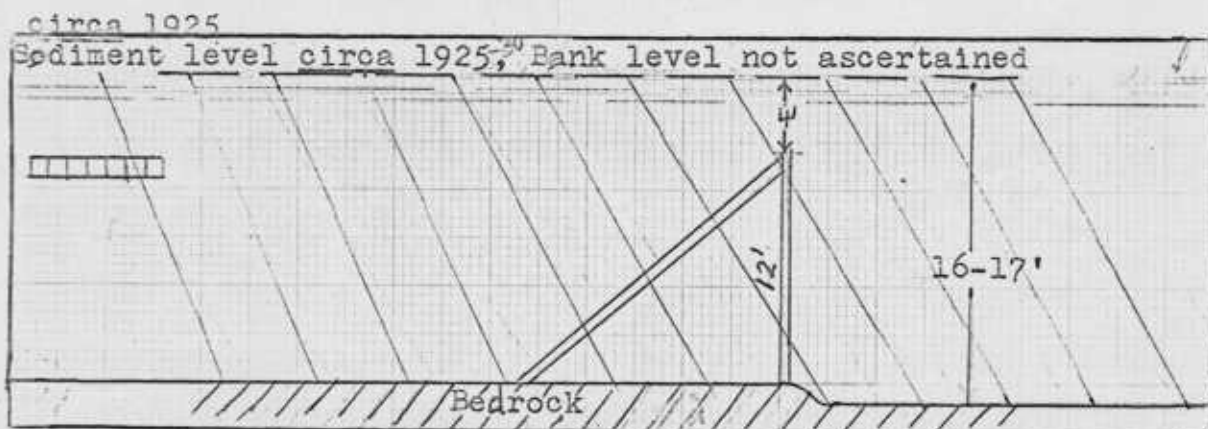
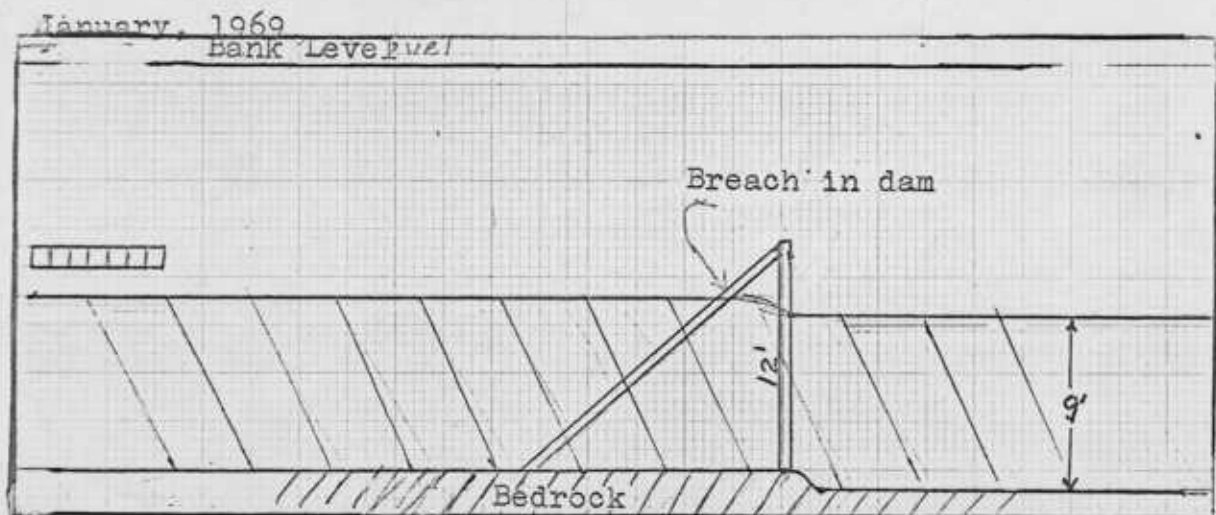
Mauldin's Millsite, Longitudinal Profiles, 1865-1969

The dam, mill, and a bridge which crossed beneath the surface of the millpond were built circa 1865.¹ The dam was built on bedrock and was ^{Twelve}12 feet high. According to a dated deed, the dam was only 9 feet high by 1896.² This indicates ^{Three}3 feet of filling below the dam which, in turn, indicates that the mill pond had filled by that date. By 1906, there was so little head available (caused by filling of the creek downstream from the dam) that the turbines were no longer efficient and the mill was abandoned. A witness who saw the dam immediately after the mill was abandoned stated that there was only ^{Three}3 feet of fall.³ At this time the banks were ^{Two and one-half}2½ feet higher than the top of the dam and were essentially in their natural condition. By 1925-30, the stream bed was ~~at its highest level~~ and was approximately ^{Four}4 feet above the top of the dam. The stream later started degrading itself and the dam reappeared 20-25 years ago. The stream bed ^{immediately} downstream from the dam is now approximately 3 feet below the level of the top of the dam. ^{Downstream,} There has been extensive removal of sand from the streambed ~~downstream~~, and this accounts for much of the degradation.

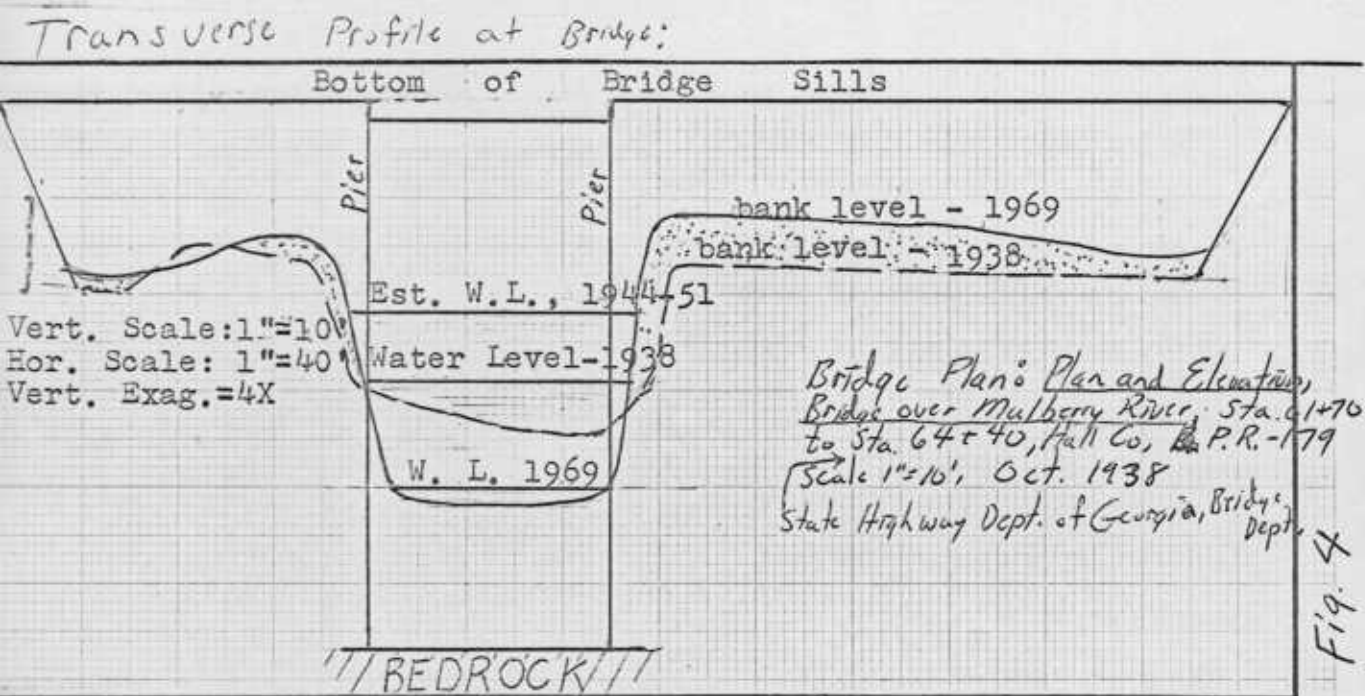
Investigation Site No. 2
Fig. 4
The valley floor filled with sediment, and swamps were formed on both sides of the stream above the bridge. The right bank swamp above the bridge was drained in 1945-46 by the use of ditches. This built-up land was seldom flooded and was used for pasture. The north bank swamp, formed after 1938, still exists even though the stream level is several feet below the level of the water in the swamp. ^{The swamp does not drain because the natural levee acts as a dam.} The river has been degrading for the last 12-15 years. This degradation process has been greatly accelerated by the removal of sand directly downstream from the bridge. Evidently, the increase in surface discharge after the removal of sand was enough to initiate the degradation.

Degradation has had serious effects at this site because the lateral cutting action of the stream is undermining the sandy alluvial banks, and the weight of the trees along the stream is causing large portions of the bank to slip into the stream. The right bank upstream from the bridge has ^{had} 10-20 feet removed in recent years, with 5-15 feet lost during spring, 1969.

Large cracks, similar to earthquake fissures, have opened in the bank, and the next high water may cause several large pieces of the bank to slide into the river. Large trees which have fallen into the water as a result of this process may tend to retard further degradation.

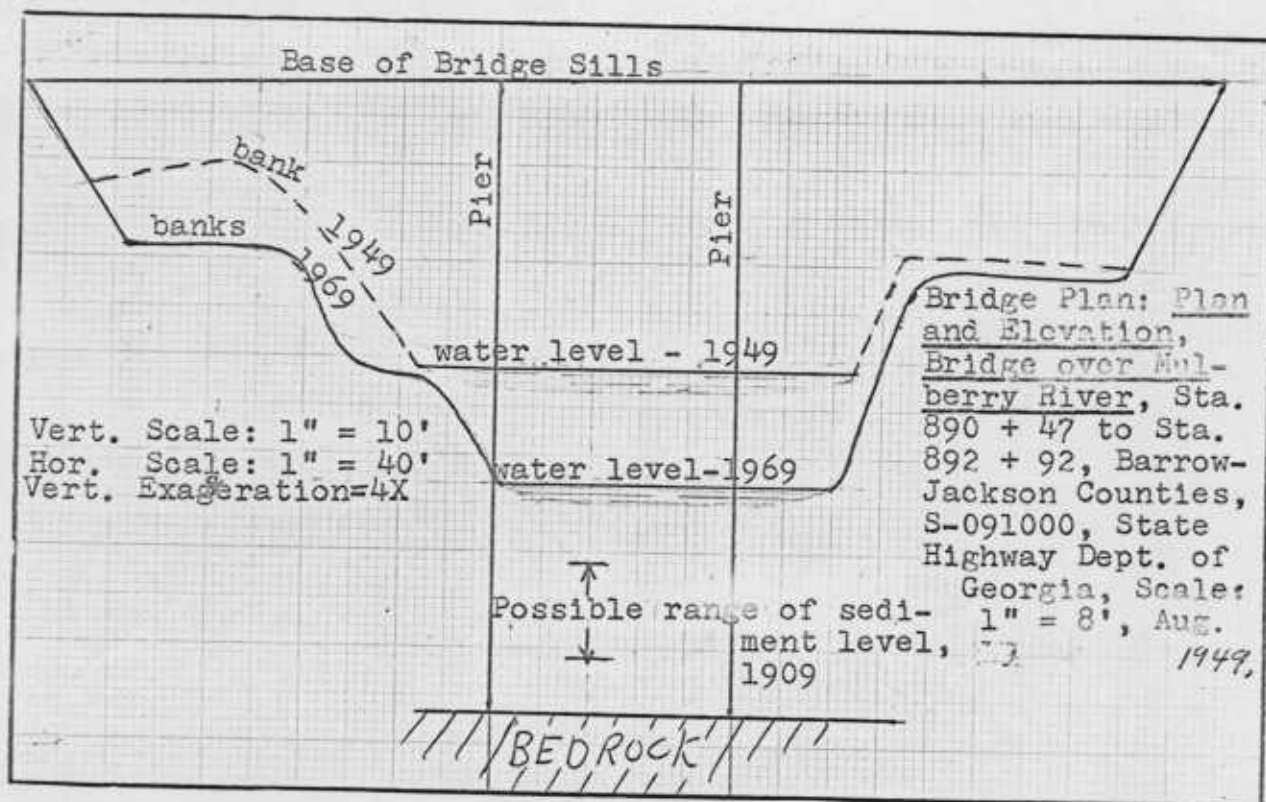
Transverse Profile at Bridge

Although this site was not specifically mentioned, this section of the Mulberry River had from three to eight feet of sand over bedrock in 1909.¹ By 1949, as shown in the ^{Fig 6} diagram, the water level was eighteen feet above bedrock. The removal of sand at this site has caused degradation as at Investigation Site No. 2, and the water level has been lowered six feet.

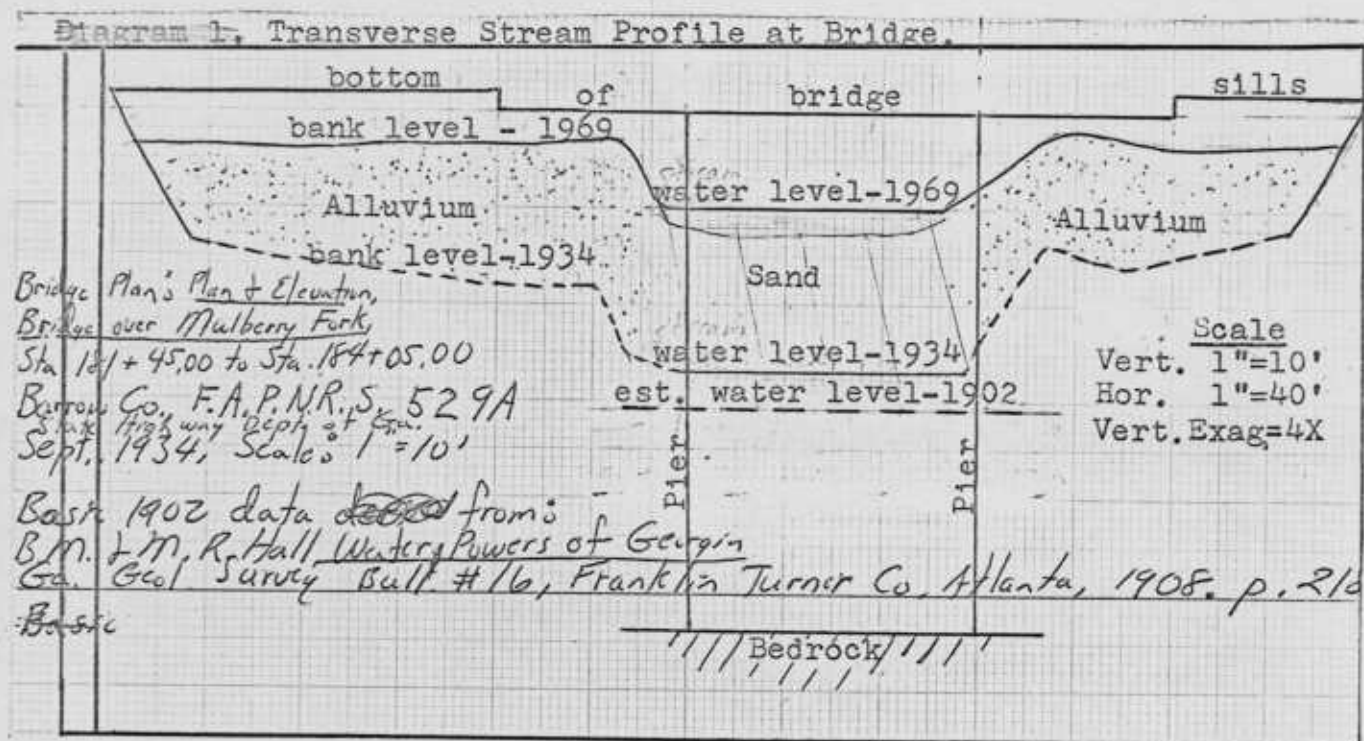
Fig 7.
As shown in diagram 1, the streambed at the bridge has aggraded $8\frac{1}{2}$ feet since 1934 and approximately twelve to thirteen feet since 1902. The area of opening under the bridge has been reduced to a fraction of the original, and high water often overflows the bridge.

Fig 7
The river in the site area is still aggrading as will be shown ^{later} in the discussion on Gunnin Lake. The sediment material appears to be coming from the upstream degradation discussed in Investigation Sites 1, 2, 3, and 4. The city of Winder, Georgia, in 1966 built a dam and reservoir one mile downstream from the Highway 53 bridge. This dam,

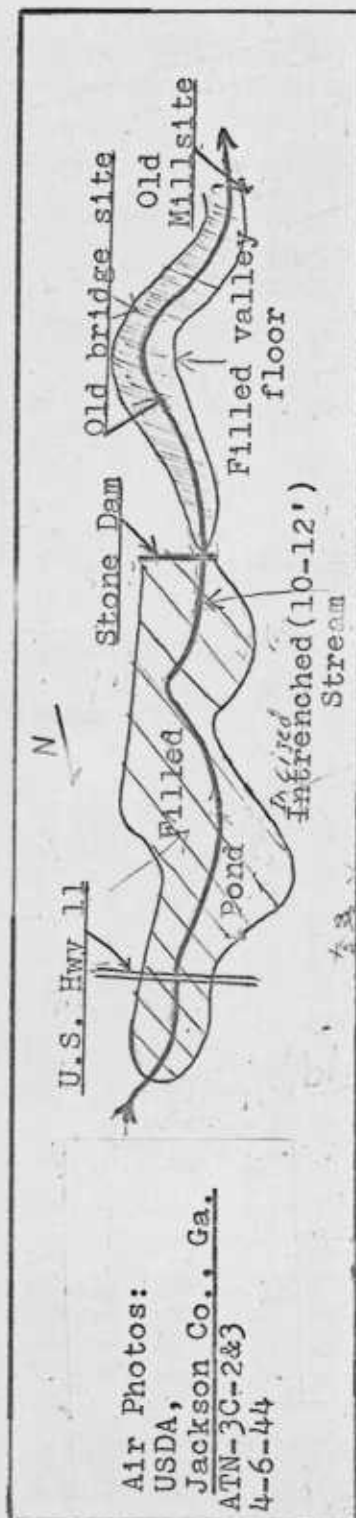
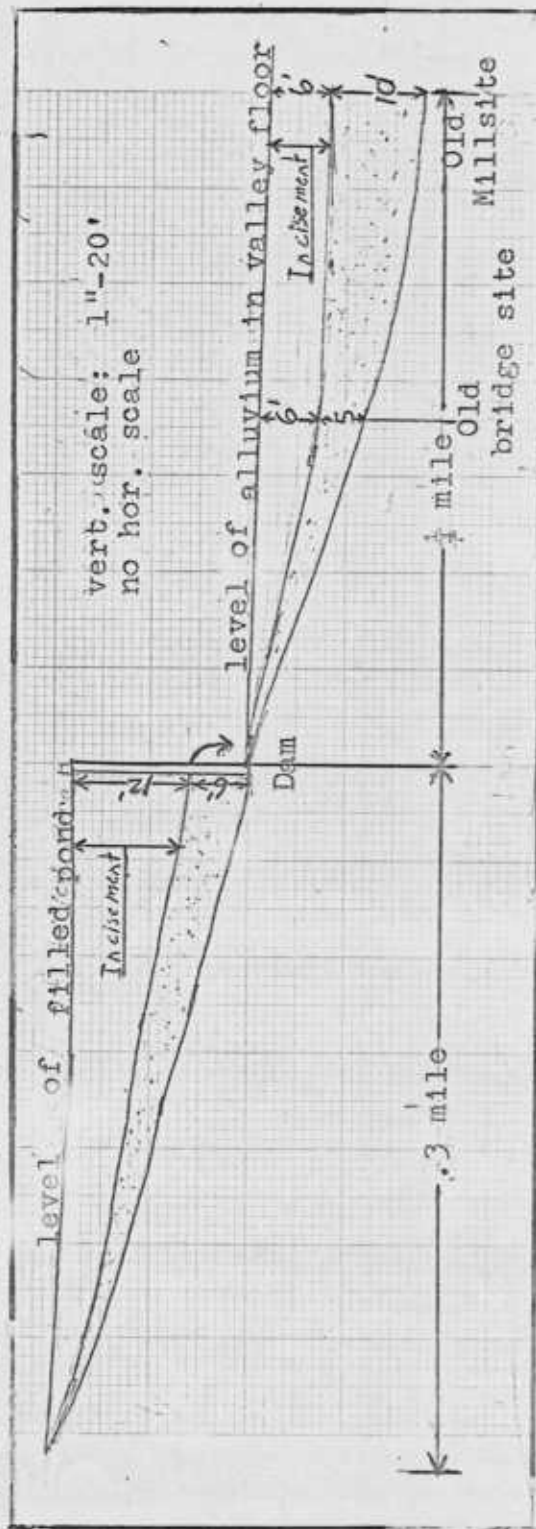
Flanagan Millsite

The 18-foot stone dam was built to replace an older, lower wooden dam in 1915. As shown in Fig. 10, the mill was approximately $\frac{1}{4}$ mile downstream from the dam. The creek flowed on bedrock past the mill as late as 1918.¹ The pond, however, had already begun to fill with sediment by 1918, and the upstream end was filled by the early 20's. Cattails and brush growing in the upstream end helped speed the deposition. The pond was often drained during this era, but to no avail; by 1932-33, the pond was completely filled except for a small pool above the dam.

The level of the streambed downstream from the dam remained static from the mid-30's until recently. In the past five or six years, the stream has degraded itself four to five feet. The present longitudinal stream profile is shown in Fig. 10.

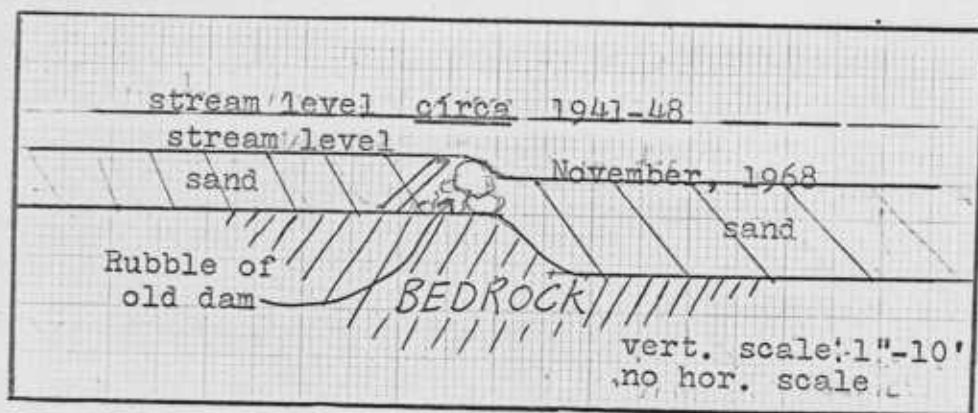
Fig 12

This millpond began filling before the turn of the century. By 1905-10, the millpond had completely filled and the stream below the dam had filled high enough so that the turbine was no longer useful. ^{1 By 1915,} The dam was later completely covered by sediments and remained covered until recently.² The streambed level before 1941 has not been ascertained, but evidently was not significantly above the level shown ^{in Fig 12} for 1941-1948 when the level was known to be static. The stream began degrading at this site circa 1948, and the milldam has only recently been uncovered. A single heavy rainfall and consequent high stream discharge in January, 1969, caused the streambed to degrade approximately six inches. Several inches were also removed from the right bank. According to the Barrow County Soil Conservation Agent, Mr. Sam Dunaway, the entire stream with the exception of the last one-half mile is degrading. *The sediment materials are entering the Mulberry River upstream from Site 5.*

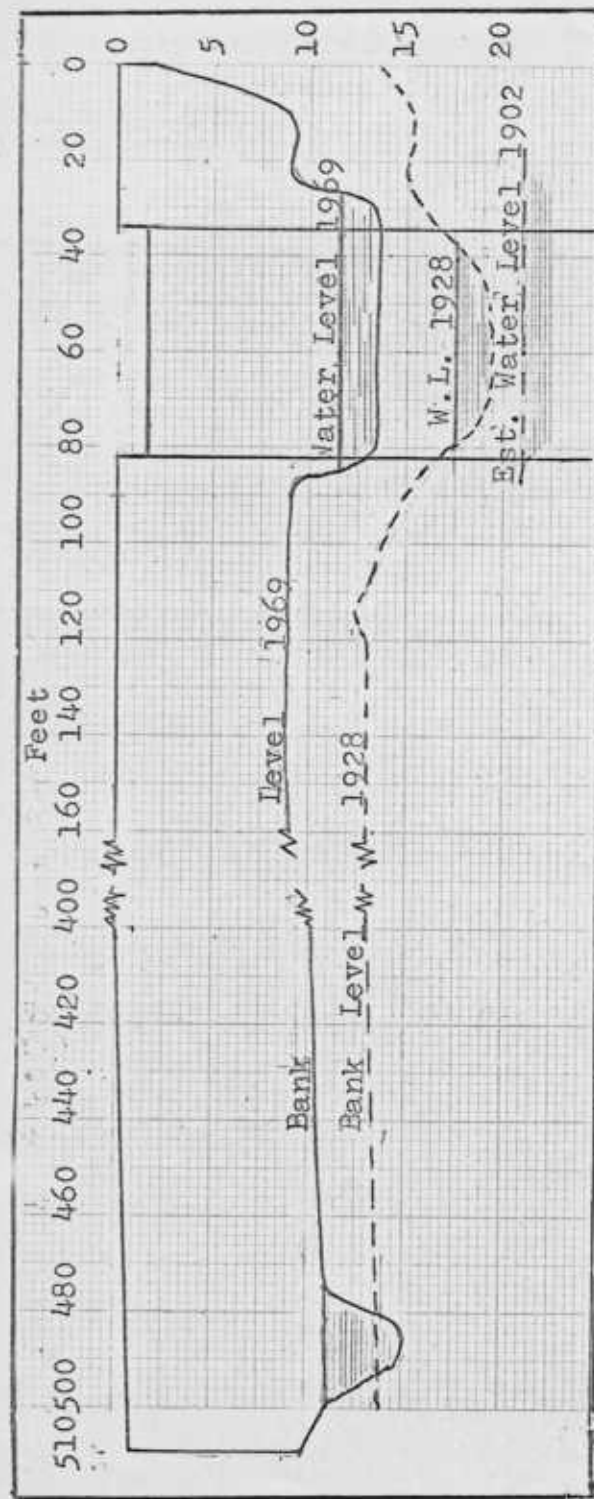
Transverse Profile of Highway 11 Bridge over the
Middle Oconee River at Investigation Site 12

The new streambed was very unstable and fluctuated considerably in 1928.⁴ The average stream level of 1928 was an approximate three to four foot increase from the estimated 1902 stream level as shown in Fig. 14. The stream has continued to aggrade since 1928 and at present (April, 1969) the stream level is six feet above that of 1928. This aggradation is corroborated by local residents who state that the swamps and lakes are becoming much more pronounced. The remains of large trees which have recently been killed, evidently by the rising water level, give mute testimony to the rising water level. Downstream 1.4 miles along the new channel, immediately below the old millsite, there is now 13 feet of channel sediment covering the bedrock shoals over which the river flowed before 1918.

This site, once excellent farmland, has become swamp in less than a century through the process of sedimentation. Because of the low gradient (four feet per mile) the stream at this site is still aggrading. Sediment material/^{is} being furnished by up~~e~~stream tributaries which are degrading. The aggradation and consequent ris^{ing} of the stream level is creating many ponds and lakes along both sides of the river.

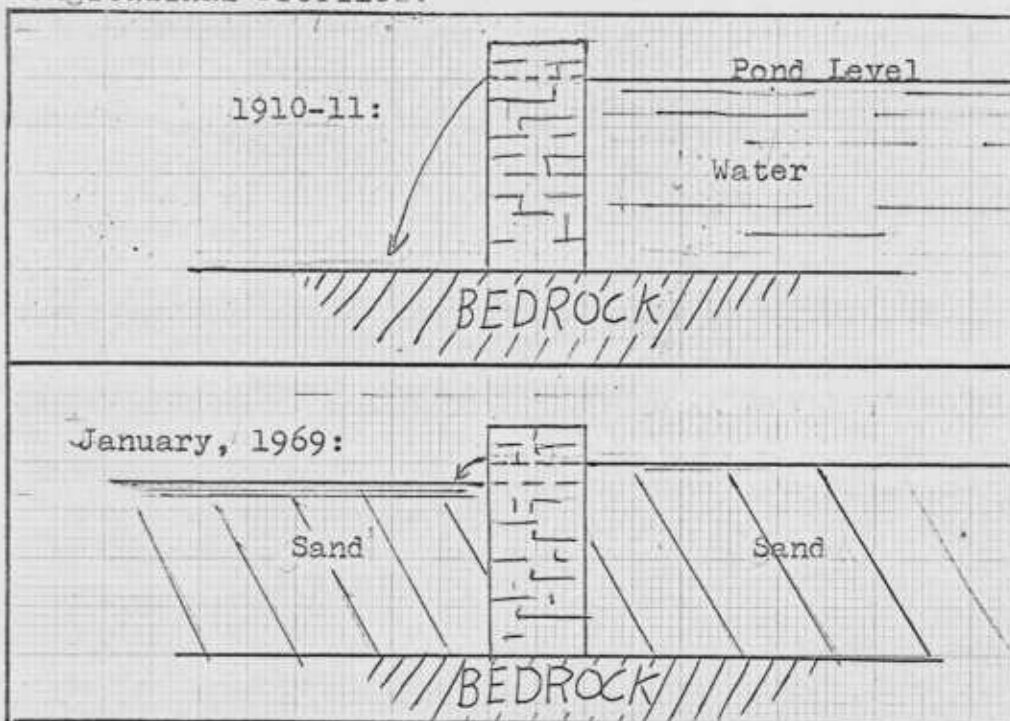
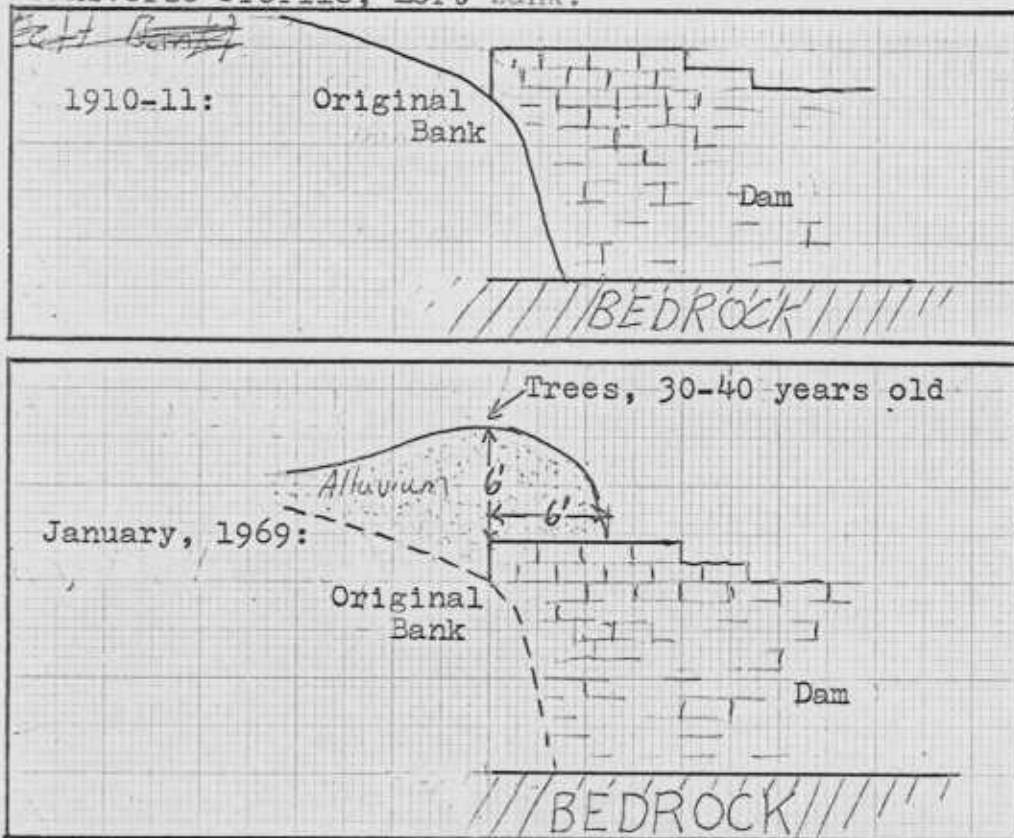
Longitudinal Profiles:

The ~~rock~~^{stone} dam, which was built on bedrock in 1910-1911, was 12 feet high and stood approximately 2 feet above the banks. ^{as shown in Fig. 15} By 1915, the pond and stream below the dam had filled with sand and the turbines were no longer operable. The stream was also prone to flooding. By the 1930's, only ripples in the water marked the presence of the dam buried beneath the sand.² The exact level of the streambed during this period has not been ascertained. The dam remained thus buried until the late 50's or early 60's, and the stream has degraded itself approximately 3 feet since the dam reappeared. There has also been lateral cutting action which has ~~undermined~~ been undermining the natural levees, ^{This has} caused trees to fall into the stream thereby slowing the degradation.

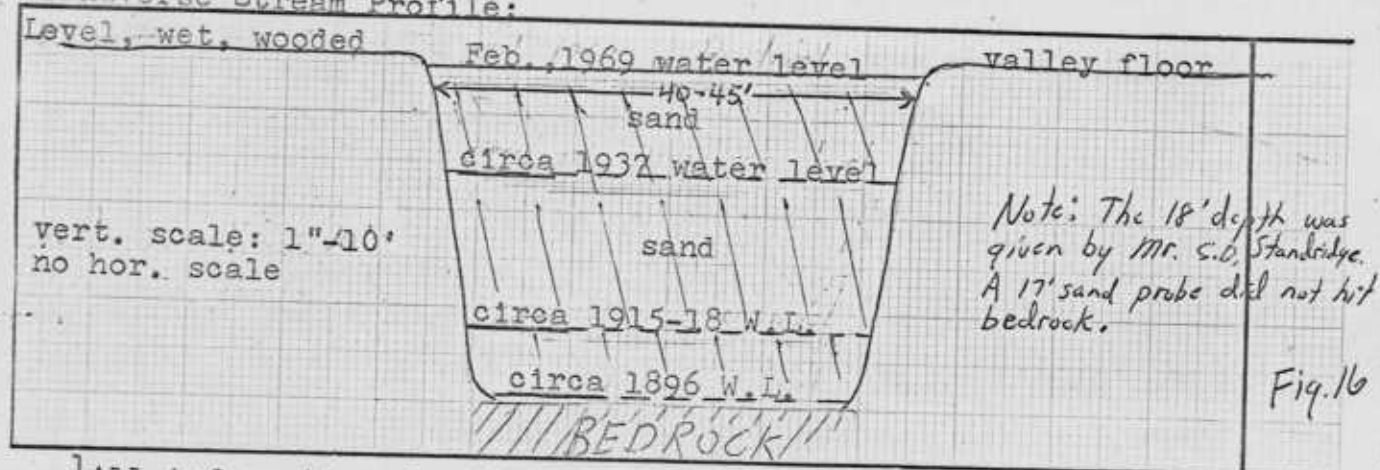
Transverse Stream Profile:

By 1937-38, the walls were 6 feet high. The WPA cleaned the logs, limbs, and other debris from the streambed and the level dropped 6-7 inches. The stream filled to its former level a year later, and sedimentation ~~resumed~~ ^{has continued} until, at present, the wall is 6 inches high ^{as shown in Fig. 16,} the stream having filled 1-2 feet in the past 20 years. The streambed level now appears to be static, and is again filled with logs, trees, limbs, and debris which would appear to be preventing degradation. The people in the area once ^{think} thought that the millpond at Athens (18-20 miles downstream) kept the streambed level up, but there ~~this~~ ^{has not been ascertained.} ~~has been no change since said dam broke in June, 1967.~~

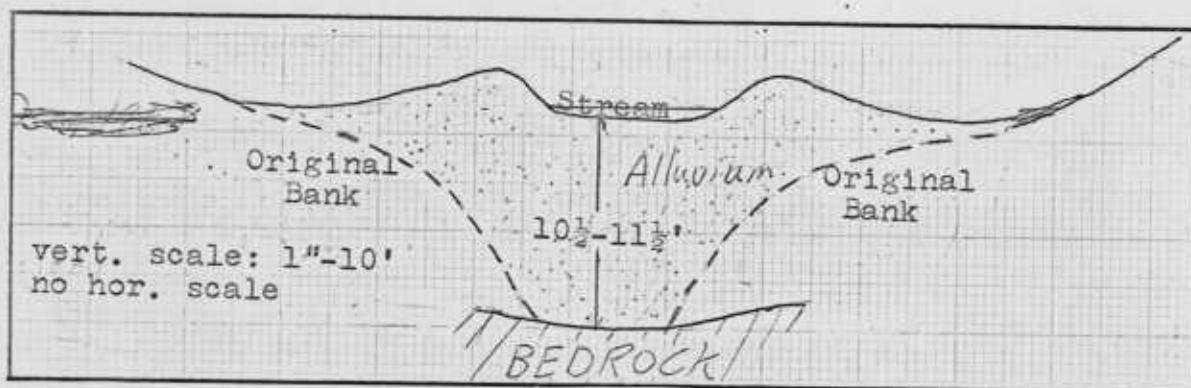
Transverse Stream Profile, December, 1968.

The stream at this site was flowing over bedrock shoals as late as 1918.¹ Most of the sedimentation took place before 1935; since that time it has filled approximately 3 feet, *with only 1 foot ^{having been added}* in the past 20 years. Natural levees are now 2 to 3 feet above the stream level which is approximately level with the valley floor. The streambed level now appears to be static. The streambed is now filled with logs, limbs, old tires, and other debris, and the stream will probably have difficulty degrading itself.

Several depth probes along 400 feet of the streambed gave varying depths indicating that the stream has made minor course changes in the process of sedimentation. A narrow valley at this point, *however,* held course changes to a minimum. Approximately one-half mile upstream is a large swamp caused by the *sedimentation.* ~~silt~~ing.

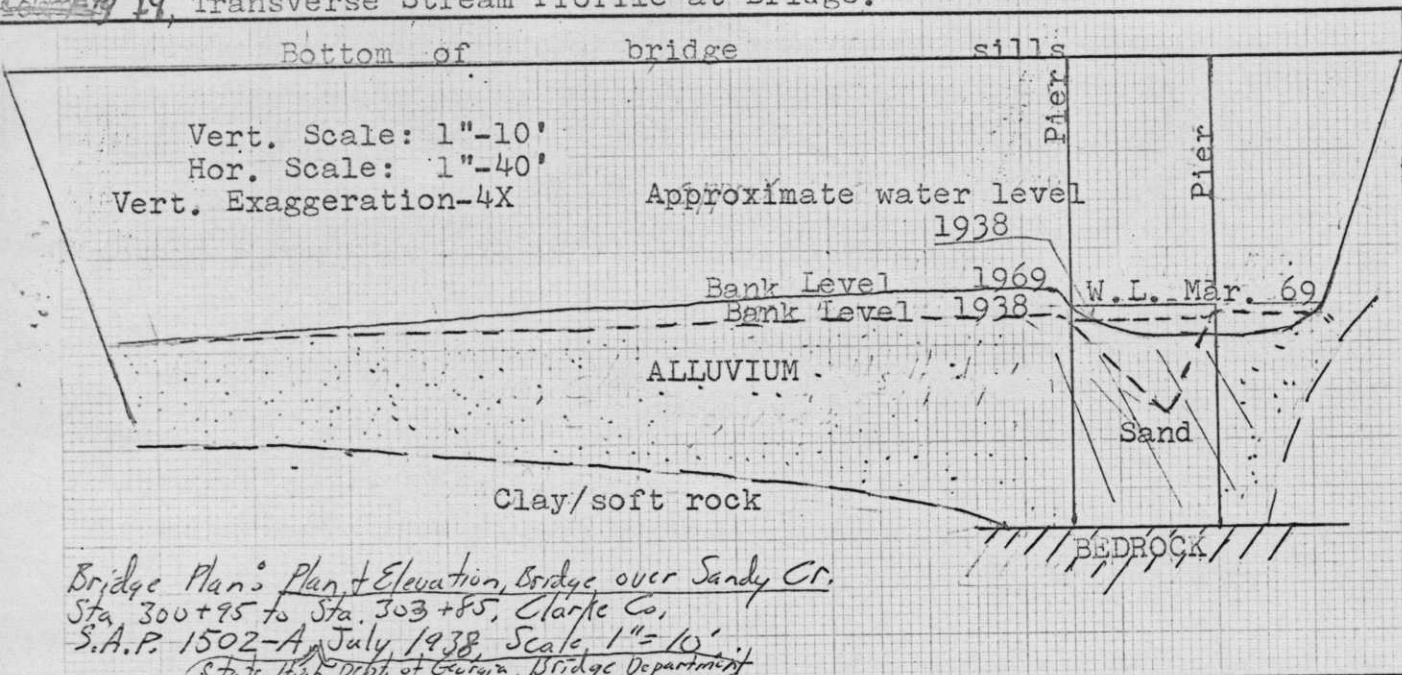
Fig 19, Transverse Stream Profile at Bridge.

No local resident contacted by the investigator concerning this Investigation Site could remember the area not being wet or swampy. ^{However,} After investigation of this area and in light of previous work done in this study, the investigator felt that this swampy area along Sandy Creek had developed since European settlement. This hypothesis was further strengthened by the knowledge that, since 1801, there has been a dam at Athens on the North Oconee River, only 2.2 miles downstream. This dam and the pond would have caused the sediment-laden stream to deposit its load, creating a channel plug with sedimentation progressively moving upstream.¹ Field observation at the Sandy Creek site revealed many large trees which, presently standing in water in the adjacent valley floor swamp, are now dead or dying. Along the stream, trees have their bases two to three feet below the surface of the stream. Many of these trees are also dead, and stumps can be seen below the stream surface.

Conclusions: It is the investigator's opinion that the wet, swampy area between the Highway 441 bridge and the mouth of Sandy Creek was low, fertile, tillable, and relatively dry land before European settlement, inundated perhaps only during ~~periods~~ floods. The combination of accelerated erosion and the raised base level at the mouth of the creek caused sedimentation to a point whereby the stream level and consequent ground water level were raised above ground level. The result has been perennial surface water to either side of the main stream so that a swamp ecology has developed in the past 50 to 100 years.

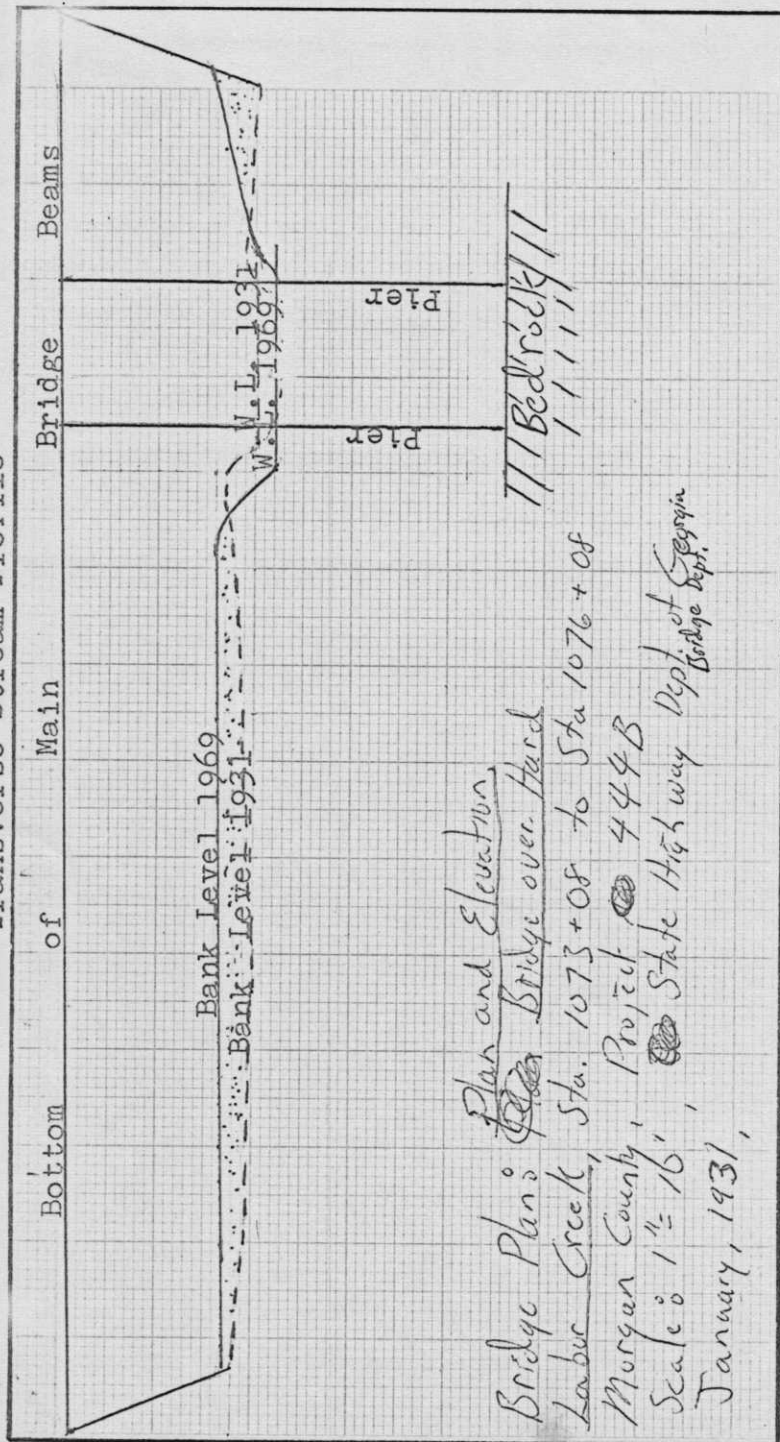
Vertical Exaggeration = 4X
Transverse Stream Profile

~~Diagram~~ Fig 23 shows that although the stream banks have aggraded somewhat since 1931, the stream level has lowered approximately one foot during the same period. Big Sandy Creek, ^{at Site 20} only $2\frac{1}{2}$ miles to the north, aggraded 2 feet during the same period of time. Inasmuch as the two streams flow parallel to one another and, in fact, join before flowing into the Appalachian River, an attempt was made to analyze the variation in processes of the two streams. The ^{causes of variation} are:

2. Two large lakes have been impounded on Hard Labor Creek. Because these lakes entrap most sediment load, ^{especially bed load,} and increase the competence of the effluents, the downstream channel should have a tendency to degrade.²³

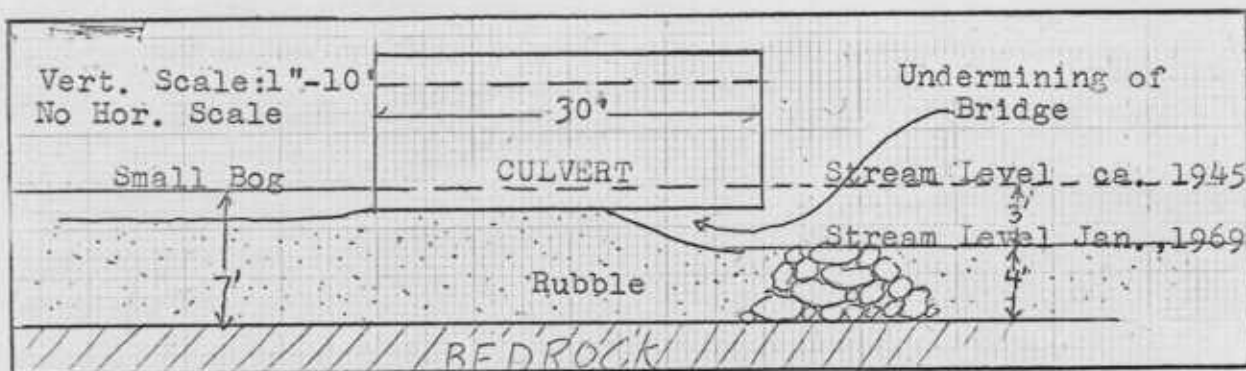
Longitudinal Stream Section at Bridge.

The creek was flowing on bedrock upstream from the bridge^{site} as late as 1880.¹ There has been sedimentation of the stream channel since circa 1915 or before.² The bridge was built 1944-1945. At that time, the streambed (sand) was flush with the sills of the bridge, both above and below the bridge. The stream level below the bridge (which acts as a dam) has degraded 3 feet in the past 24 to 25 years; however, most of the degradation has taken place within the past few years. The bridge is being undermined at the downstream end, and it is possible that the stream will flow under the bridge sills in the near future unless some action is taken. The creek should not lower itself considerably directly below the bridge because of rubble and stones in the streambed.
